# Failure Mechanism of Anchored Retaining Wall due to the Anchor Head Itself Being Broken

Itoh, Kazuya ...[et al]. Failure Mechanism of Anchored Retaining Wall due to the Anchor Head Itself Being Broken. Proceeding of TC302 Symposium Osaka 2011 : International Symposium on Backwards Problem in Geotechnical Engineering and Monitoring ...

Kazuya Itoh, Naotaka Kikkawa & Yasuo Toyosawa

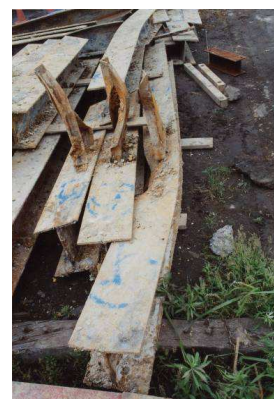
(c) Damaged H- steel for anchor head

Due to this collapse, eleven H- steel piles toppled. Four workers at the bottom of the excavation site were buried alive and three workers were struck by H- steel piles. As a result, five workers were killed and two others were injured.

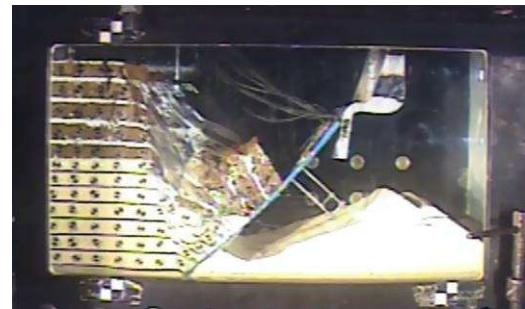
(b) Kanto loam and sand layer

The model consisting of Kanto loam and sand layers is shown after collapse in Fig. 11(b). The failure happened suddenly when the penetration depth reached about 60mm. The failure line's angle in the sand was about 65 degree.
